Manhole Inspection Summary

Manhole # S31E__046MH

Insp Date: **12/16/08 9:29 AM**

Location Address: **N Lexington St**

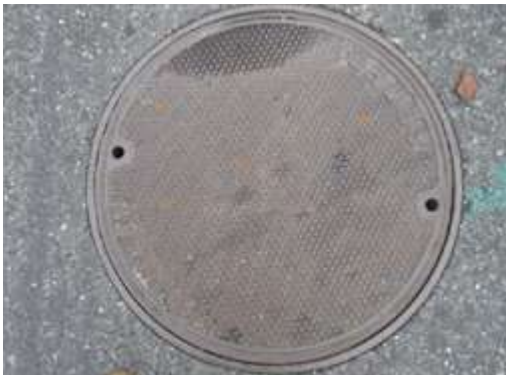
Condition: **Sound**

cover pic

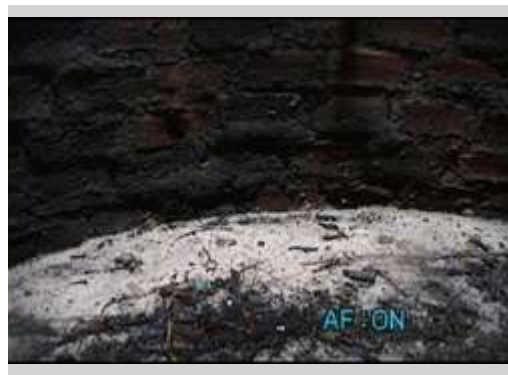
Defect 3

Condition: ☐ Sound ☐ Cracked ☐ Root Intrusion ☐ Deteriorated ☐ Leaks ☒ **Debris**

debris on bench

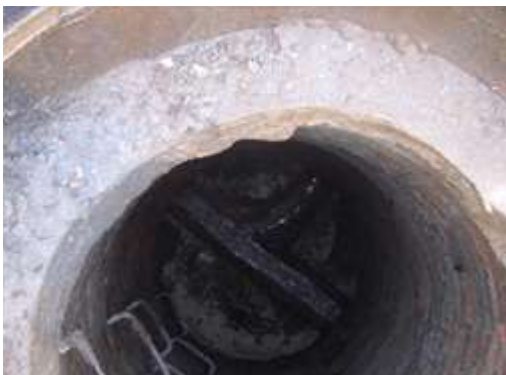
Defect 5

Offset: **4** (in.)

☒ **Leaks**

4 inch offset

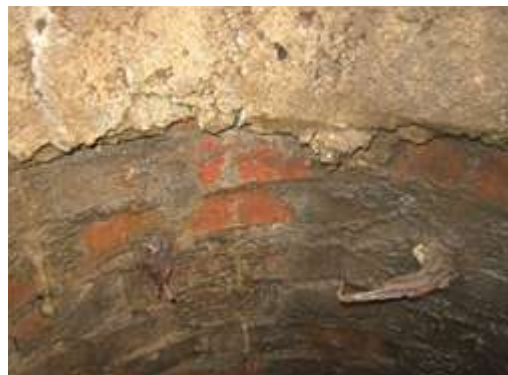
Defect 2

Count: **7** Missing: **1** ☒ **Corroded**

corroded missing rung

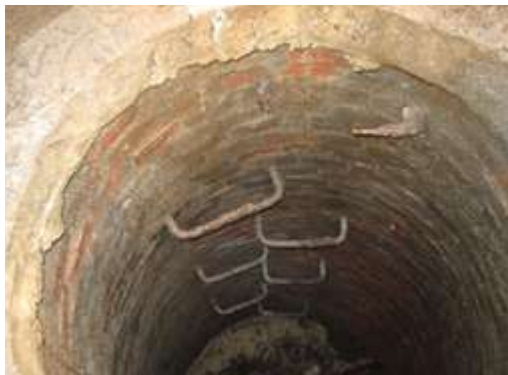
Defect 1

Infiltration: ☐ None ☒ **Joint** ☐ Cracks ☐ Mortar ☐ Roots ☐ Wall

infiltration chimney/frame joint

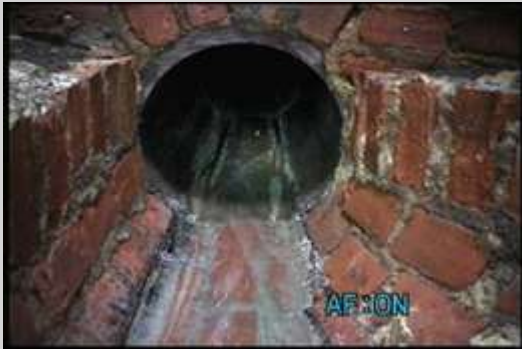
12 O'Clock Outflow

10 in. Circular Gravity Sewer
Pipe Out @ 12 O'Clock

Pipe Height: **10.8** (in.) Rod and Bar (Angled)
Pipe Material: **Clay** ☐ Pipe Lined
Invert Depth: **11.44** (ft.) Flow Characteristics: **Fast**
Deposits: ☒ None ☐ Mud ☐ Sludge ☐ Debris ☐ Grease
Silt Depth: **0** (in.) Deposits Extent:
Infiltration: **None** Pipe Seal Cond: **Sound**

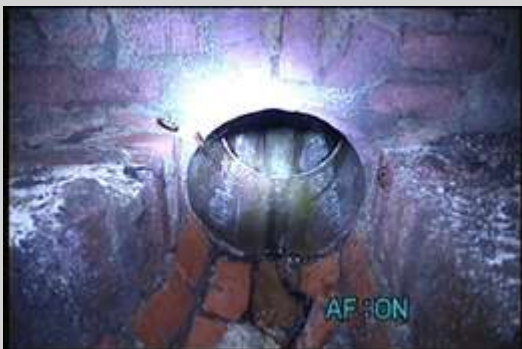
3 O'Clock Inflow

8 in. Circular Gravity Sewer
Pipe In @ 3 O'Clock

Pipe Height: **8.4** (in.) Rod and Bar (Angled)
Pipe Material: **Clay** ☐ Pipe Lined
Invert Depth: **11.02** (ft.) Flow Characteristics: **Slow**
Deposits: ☒ None ☐ Mud ☐ Sludge ☐ Debris ☐ Grease
Silt Depth: **0** (in.) Deposits Extent:
Infiltration: **None** Pipe Seal Cond: **Sound**

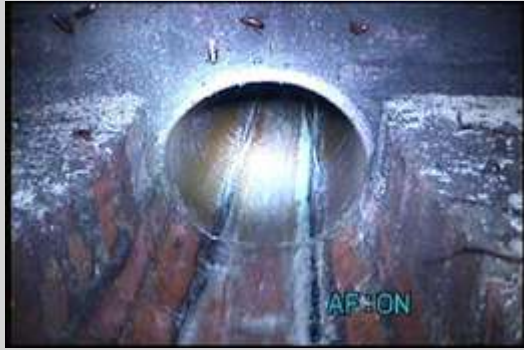
6 O'Clock Inflow

10 in. Circular Gravity Sewer
Pipe In @ 6 O'Clock

Infiltration: **None** Pipe Seal Cond: **Sound**
